# PARTIN SETTLEMENT ROAD WIDENING EXISTING CONDITIONS REPORT

Submitted to: Osceola County Transportation and Transit Department

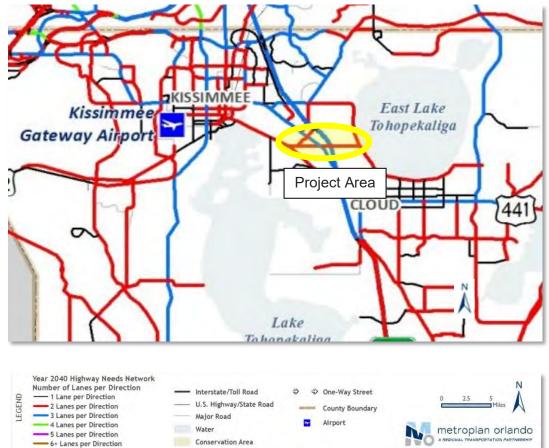
Figure 2: Highway Needs Network Map

The Metro Plan Orlando 2040 Long Range Transportation Plan indicates that an increase to two lanes in each direction will be required for Partin Settlement Road.

This improvement is included in both the Highway Needs Network and Cost Feasible Needs Network plans.

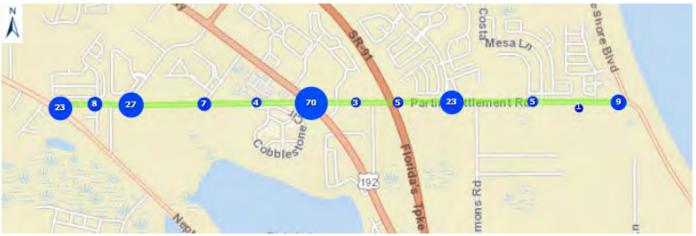
Crash Location Map

The corridor has seen above statewide average crashes each year, with 2019 being the highest. There have been no fatalities, although 32% of the crashes were injury related. The majority of crashes along the corridor are rear end collisions (61%), followed by left turns (16%).

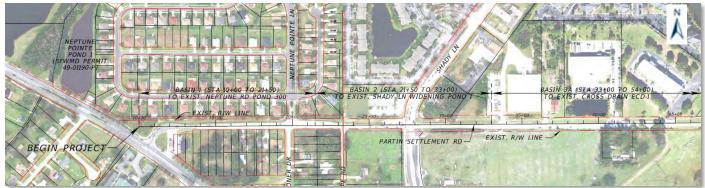
Figure 3: Drainage Basin Map - Basins 1, 2, 3A

The project is located within the Kissimmee River Basin and ultimately outfalls to the Gulf of Mexico via Lake Okeechobee. There are eight (8) drainage basins along the project corridor. Basins 1 through 7 discharge to locations upstream of Lake Tohopekaliga and Basin 8 discharges directly to East Lake Tohopekaliga. Runoff in Basins 1, 2, 4, and 7 are conveyed to existing offsite ponds for treatment, runoff in Basins 3, 5, and 6 discharge offsite without treatment, and runoff in Basin 8 receives some treatment within the onsite roadside ditches before being discharged offsite.

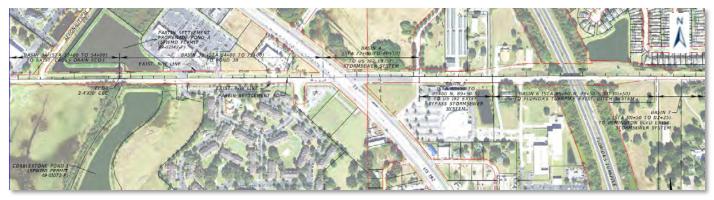
Figure 4: Drainage Basin Map - Basins 3A, 3B, 4, 5, 6, 7

The limits of existing Basin 3 are from approximately 510 feet east of Shady Lane (Station 33+00) to just west of the intersection of Partin Settlement Road and US 192 (Station 72+00). Runoff in Basin 3 is conveyed to ECD-1, at station 54+00, where the runoff discharges offsite to the south without treatment.

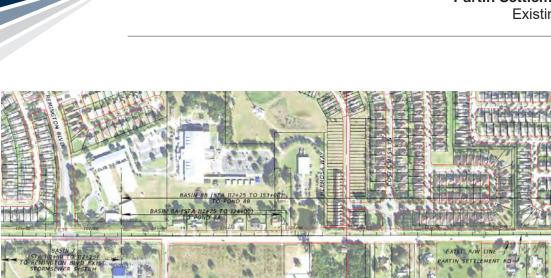
Figure 5: Drainage Basin Map - Basins 7, 8A, 8B

The limits of existing Basin 7 are from approximately 740 feet east of Florida's Turnpike (Station 101+50) to approximately 405 feet east of Remington Boulevard (Station 112+25). There is no curb and gutter along the roadway in this section, and there are roadside swales along both sides of the road. The roadside swales discharge to the Remington Boulevard storm sewer system which discharges into Remington Pond 25 from SFWMD Permit No. 49-00544-S (Remington Boulevard Extension).

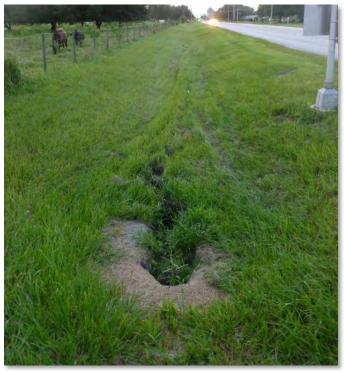
Figure 9: Typical upland-cut ditch, adjacent to Pond Site 8A(1)

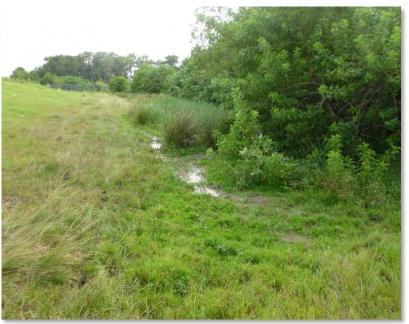
Figure 10: WOSW 10, in pasture at Pond 3B(2) Site, south side

WOSWs 9 and 10 are located behind the 15-foot-wide berm along Fish Lake Canal, south of Partin Settlement Road and just east of an existing stormwater pond (Photos 4 and 5, respectively). These lowquality wetlands comprise primarily mowed fields/grazing areas, covered by Bahia grass, spartina, and juncus, and bordered by Brazilian pepper. They are identified as a PEM1F Freshwater Emergent Wetland on NWI. The estimated impact to this wetland would be nearly 1.00 ac if Pond 3B(2) were placed at this site.

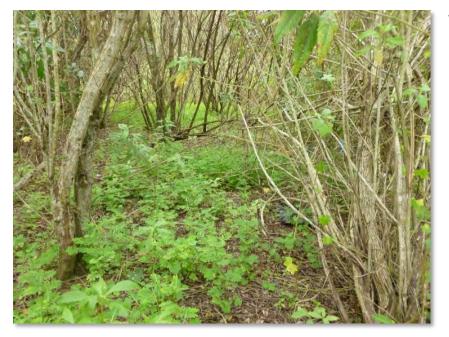
Figure 11: WOSW 11, north of existing stormwater pond, west of Publix shopping center

WOSW 11 is a medium quality wetland located in the northern portion of the site proposed for Pond 3(B)1 and drains to the Fish Lake Canal (Photo 6). This otherwise isolated system comprises mostly invasive species such as Peruvian willow (*Ludwigia peruviana*). Chinese tallow (*Triadica*)

*sebifera*), Brazilian pepper, and Carolina willow (*Salix caroliniana*), but also the opportunistic, native Baccharis (*Baccharis halimifolia*). If the pond were constructed at this site, it would impact approximately 0.75 ac.

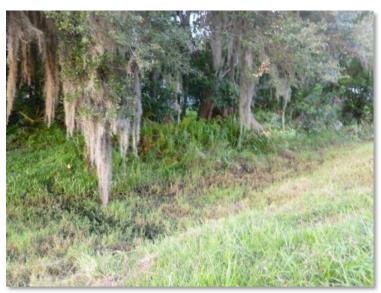
Figure 12: WOSW 17, a stream/ditch/wetland complex near E. Lakeshore Blvd intersection

WOSW 17 encompasses a tributary, wetland, and ditch (Photo 11). Vegetation comprises cinnamon fern (*Osmundastrum cinnamomeum*), Brazilian pepper, sabal palmetto, laurel oak, and red maple. Expansion of the intersection/roadway would impact approximately 0.15 ac.

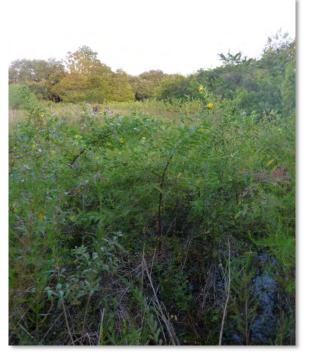
Figure 13: WOSW 14, a wetland at Pond 8B(1) Site

WOSW 14. This medium-quality wetland is in the site proposed for Pond 8(B)1 and is located in the historic floodplain of East Lake Toho. It comprises primrose willow (*Ludwigia* sp.), Sesbania (*Sesbania* sp.), Brazilian pepper, and grasses/sedges associated with wet meadow habitats, which covers a significant portion of the wetland. Impacts to this wetland to install the pond would range from 2.50 to 3.00 ac.

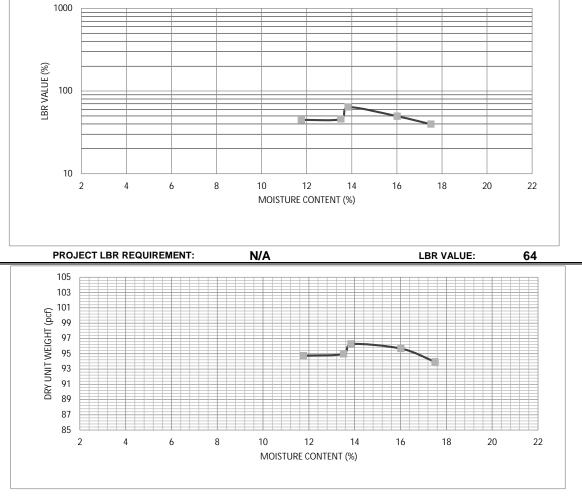
### SAMPLE LOCATION: RB-5.

SOIL DESCRIPTION: Gray Fine Sand

OPT MOISTURE: 13.8

MAX DENSITY: 96.3

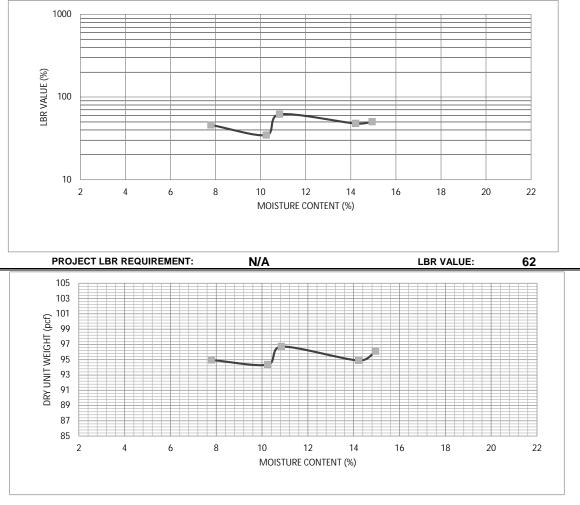
SAMPLE LOCATION: RB-25. SOIL DESCRIPTION: Gray Fine Sand

OPT MOISTURE: 10.8

MAX DENSITY: 96.7

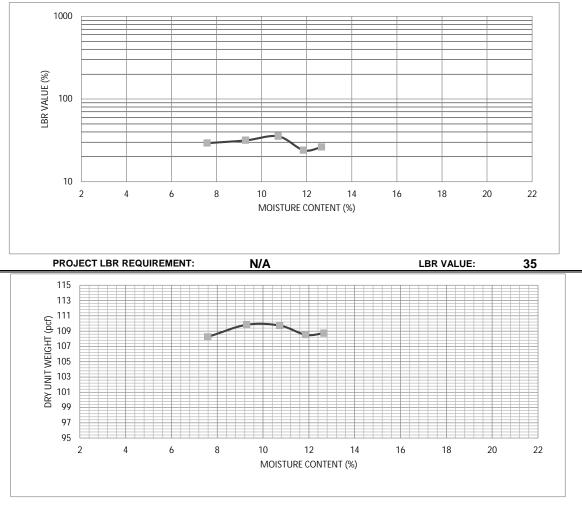
### SAMPLE LOCATION: RB-45.

SOIL DESCRIPTION: Brown Fine Sand with Silt and Trace Rock

OPT MOISTURE: 9.9

MAX DENSITY: 110.0

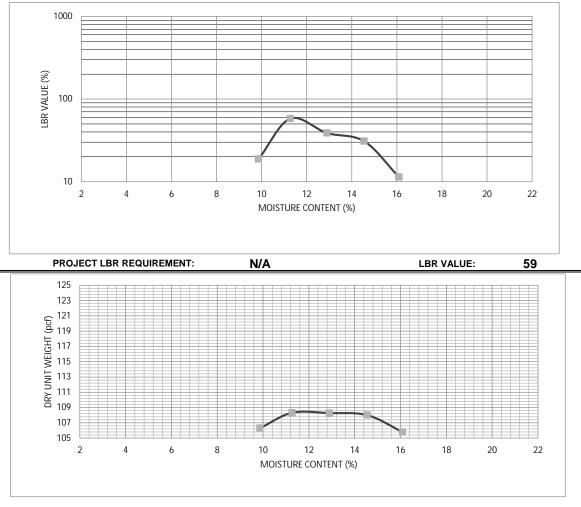
### SAMPLE LOCATION: RB-64.

SOIL DESCRIPTION: Brown Fine Sand with Silt and Rock

OPT MOISTURE: 11.9

MAX DENSITY: 108.5

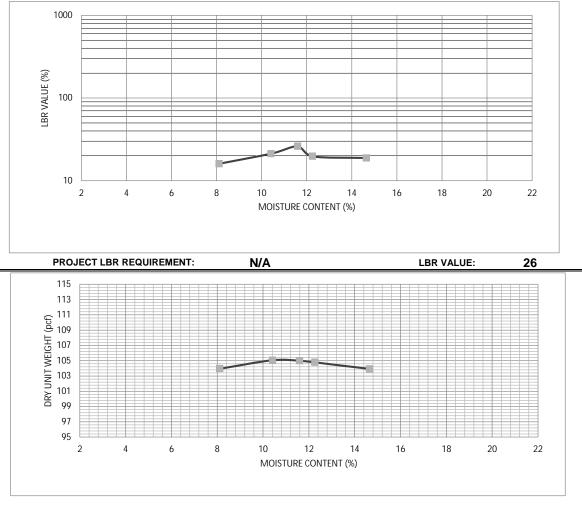
### SAMPLE LOCATION: RB-78.

SOIL DESCRIPTION: Gray Fine Sand with Silt

OPT MOISTURE: 10.9

MAX DENSITY: 105.2

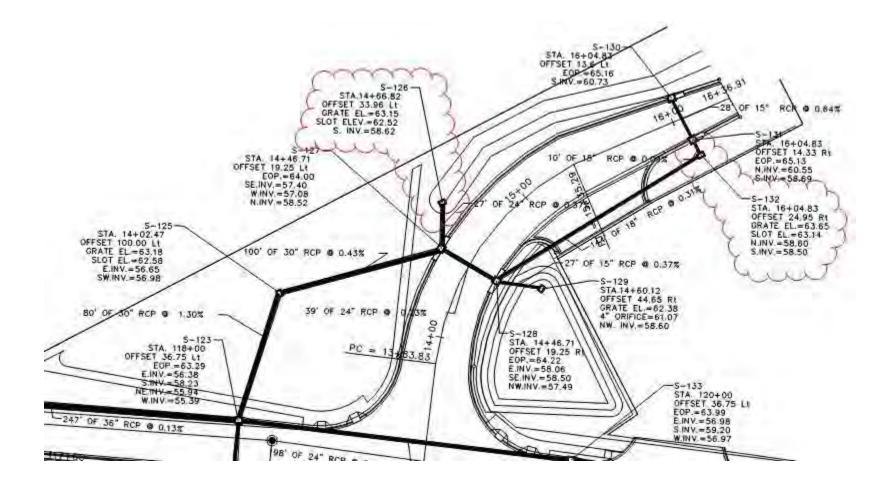
The tie-in points for the new storm sewer are indicated below with clouds. This is at the intersection with Neptune Road, where the Chevron station is located next to (east of) the pond. We may need to remove most of the system and replace with a configuration that works with our new roadway layout, thereby the controlling point could be further downstream, such as structure S-127 or S-125.

Nevertheless, the system is generally less than 7 feet deep, and our trunkline could be placed on the north side of the road to increase the offset from the Chevron station if needed.

In addition, Terracon recommends installing the stormwater trunk line from structures S-129 and S-132 be position to the north side of the Partin Settlement road to increase the separation from the Chevron site. The dewatering along Partin road should be performed as required to not influence groundwater at the Chevron site canopy structure and southward.
